FEDERAL AVIATION ADMINISTRATION AIRWORTHINESS DIRECTIVES

LARGE AIRCRAFT BIWEEKLY 2012-20

9/24/2012 - 10/7/2012

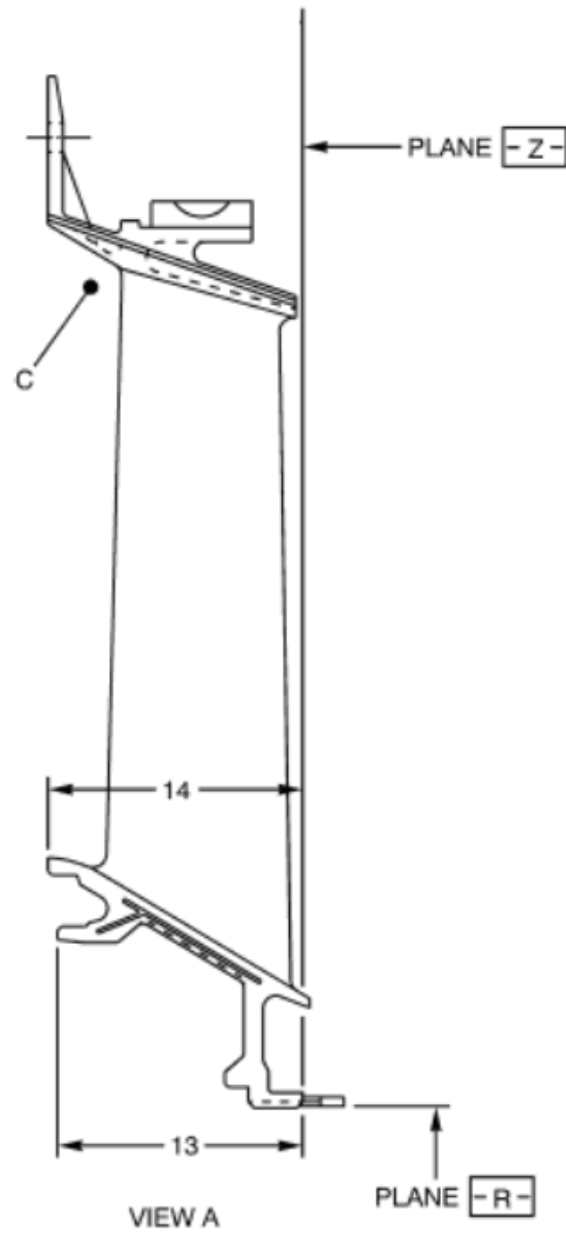
Figure 1 to Paragraph (e) - Determination of Vane Eligibility

At Section B-B (5.241 inches (133.121 mm) from rear foot outer diameter surface at Planes S, SL, and SM)	1.188 inches (30.175 mm) minimum
29	
Airfoil thickness at Section J-J (1.935 inches (49.149 mm) from rear foot outer diameter surface at Planes S, SL, and SM)	0.239 inch (6.071 mm) minimum
At Section E-E (3.181 inches (80.797 mm) from rear foot outer diameter surface at Planes S, SL, and SM)	0.183 inch (4.648 mm) minimum
At Section B-B (5.241 inches (133.121 mm) from rear foot outer diameter surface at Planes S, SL, and SM)	0.139 inch (3.531 mm) minimum
30	
Distance to trailing edge measurement	0.062 inch (1.575 mm)
31	
Airfoil trailing edge thickness	0.030 inch (0.762 mm) minimum
32	
Dimension	0.315 – 0.324 inch (8.001 – 8.230 mm) diameter
33	
Dimension	6.785 – 6.795 inches (172.34 – 172.59 mm)
34	
Dimension	0.692 – 0.714 inch (17.58 – 18.14 mm)

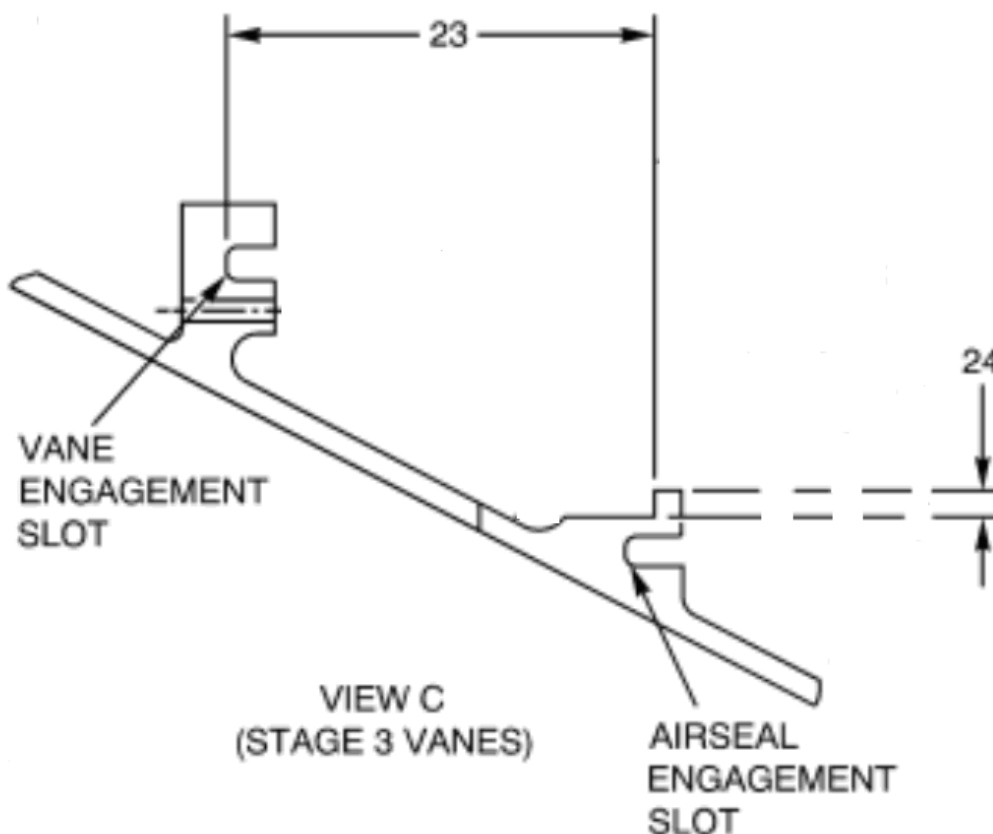
Figure 4 to Paragraph (e) - Determination of Case Eligibility

(iv) Dimensionally examine index 23 and index 24 of the vane engagement slots on the rear turbine case, where the 3rd stage vane is installed. Use Table 3 to paragraph (e) of this AD and Figure 4 to paragraph (e) of this AD to determine whether the case is eligible for installation.

Inspect:	Eligible for Installation Limits
23	1.875 inch (47.625 mm) minimum
24	0.097 inch (2.464 mm) minimum
